FINAL REPORT OF SPECIFIC PURPOSE LIDAR SURVEY

LiDAR, Breaklines and Contours for Bay County, Florida

State of Florida
Division of Emergency Management
Contract 07-HS-34-14-00-22-469
Task Order 20070525-492718a
PDS Task Order B

October 30, 2009

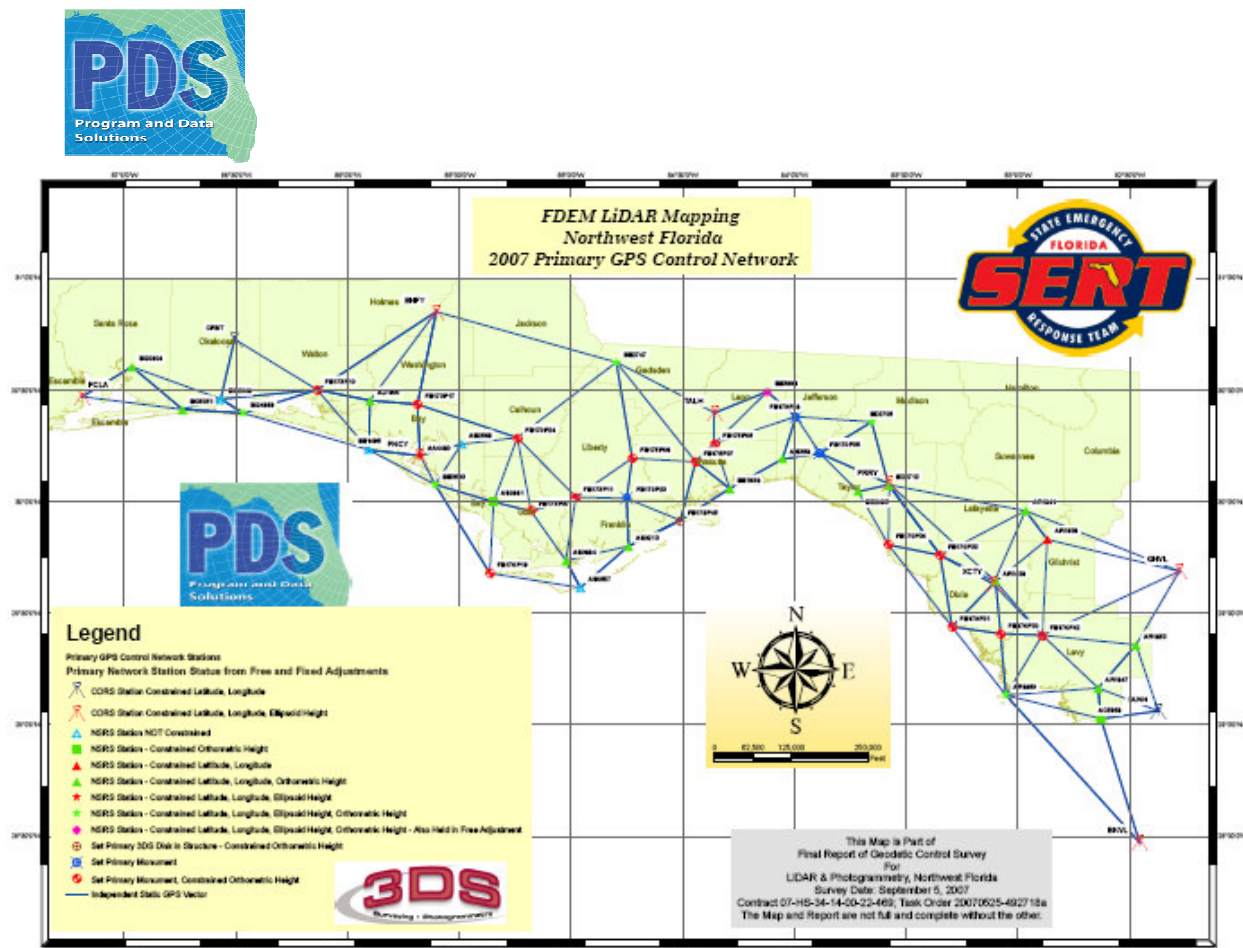
Figure 1. Primary Control Network

The Primary network stations (see Figure 1) were used as base stations supporting the airborne GPS data acquisition, and as a consistent control framework for the more densely spaced Secondary control networks, and all subsequent control surveying activity on the project. They were setup at 40 kilometer spacing per the 2 centimeter requirements for Primary Control stated in the NOS NGS-58. The Primary Control network consisted of 55 stations, including 10 Continuously Operating Reference Stations (CORS), 27 existing monuments from the National Spatial Reference System (NSRS) and 18 new monuments set so as to limit LiDAR GPS baseline lengths to 20 Km relative to GPS base stations on either side of stations spaced ≈ 40 Km apart. Third order differential leveling was used to establish elevations on 20 Primary network stations in specific areas where published vertical stations could not be occupied directly with GPS. A minimally constrained (free) Least Squares adjustment was run to verify the internal accuracy of the Primary network. After evaluating and removing any outliers, a final free adjustment was generated, consisting of 191 independent vectors. The input error estimates were scaled by a factor of 14.90 which resulted in a properly weighted adjustment with a variance factor of 1.0154, with no flagged residuals. A constrained (fixed) 3-D horizontal adjustment was run using the same input error estimates as were used in the free adjustment; the variance factor was 1.3712 and there were no flagged residuals. A constrained (fixed) 1-D vertical adjustment was run using the same input error estimates as were used in the free adjustment; Station BE3991 was fixed in latitude, longitude and orthometric height; the variance factor was 1.2866 and there were no flagged residuals.

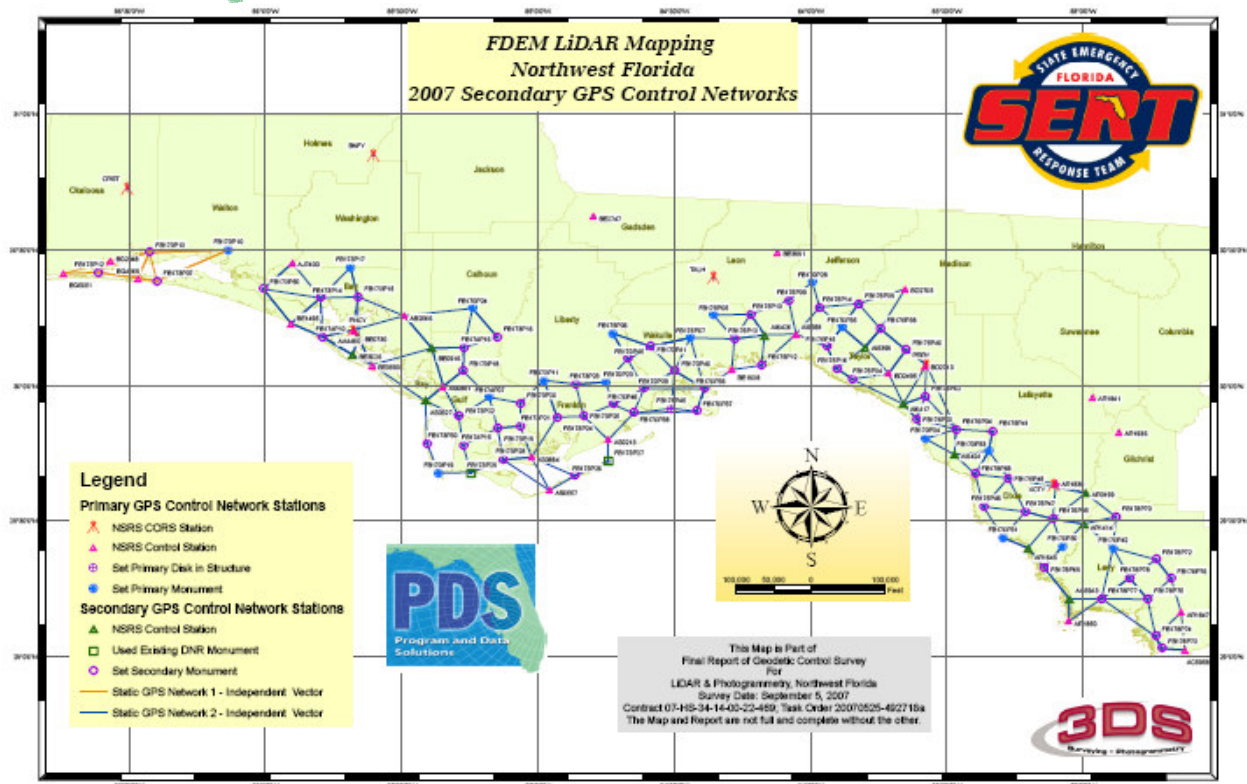
Figure 2. Secondary Control Networks

The Secondary network stations (see Figure 2) were used to support the measurement of both LiDAR and orthophoto QA/QC checkpoint sites. They were setup at 15 kilometer spacing per the 2 centimeter requirements for Secondary Control stated in NOS NGS-58.

The first Secondary Control network consisted of 4 stations in the Okaloosa County area. The second Secondary Control network consisted of all remaining mapping areas in the Florida Panhandle. The Secondary Control networks included a total of 80 control points, including 16 recovered NSRS monuments, 2 recovered DNR monuments, and 62 new monuments set for this network. A minimally constrained (free) Least Squares adjustment was run to verify the internal accuracy of the Secondary networks. After evaluating and removing any outliers, a final free adjustment was generated. This final free adjustment consisted of 254 independent vectors. The input error estimates were scaled by a factor of 6.234, which resulted in a properly weighted adjustment with a variance factor of 1.000; there were no flagged residuals. A constrained (fixed) 3-D horizontal adjustment was run using the same input error estimates as were used in the free adjustment; the variance factor was 1.6339 and there were six flagged residuals. A constrained (fixed) 1-D vertical adjustment was run using the same input error estimates as were used in the free adjustment; Station BE3991 was fixed in latitude, longitude and orthometric height; the variance factor was 1.2136 and there were no flagged residuals.

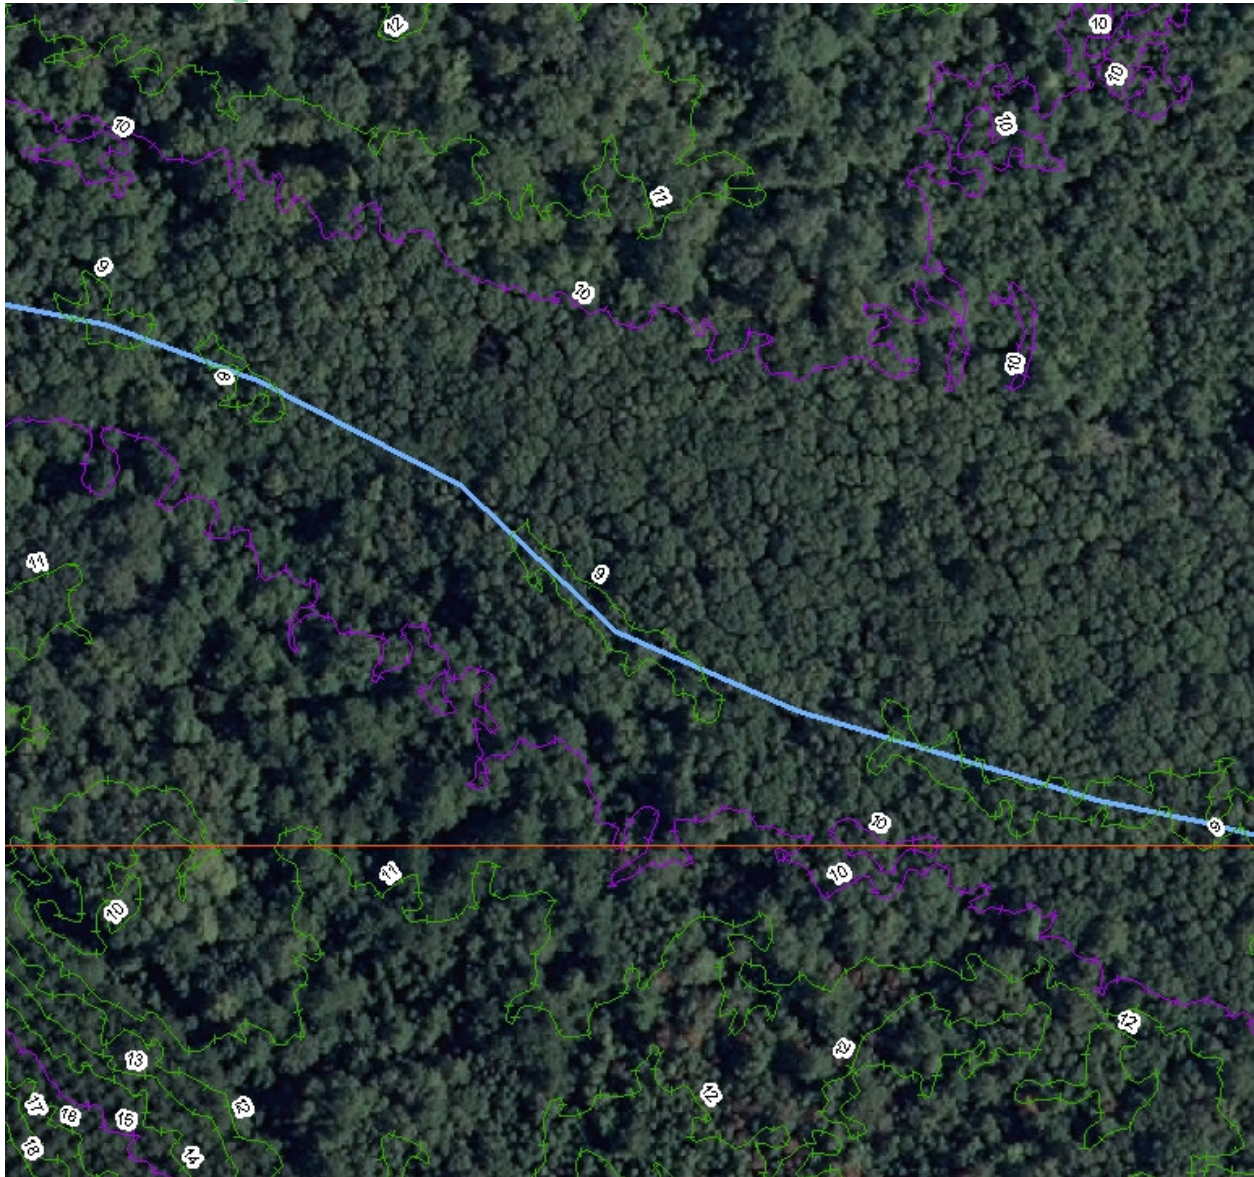
Figure 3. Even in very dense vegetation, the PDS team's high LiDAR point density (4 points per square meter) enabled the detection of dry drainage features beneath the vegetation.

The five figures below demonstrate how the PDS team’s high LiDAR point density (4 points per square meter) are used to penetrate dense vegetation and accurately map the dry drainage feature not visible from a normal digital orthophoto (Figure 1); the total density of the LiDAR point cloud (Figure 2); the density of LAS Class 2 points that penetrated to the ground (Figure 3); the color-coded Terrain to help in visualizing the variable elevations (Figure 4); and the soft hydro breakline that approximates the potential flow line of the dry drainage feature and the contours that clearly show the undulations in the Terrain (Figure 5). At Figure 5, the 9-foot contour lines are *depression contours* that surround elevation points that are lower than 9-feet. Although the undulations, by definition, are not “hydro-enforced,” the PDS Team’s PSM in responsible charge of this project considers it a violation of professional standards if one were to deliberately degrade the accurate Terrain, soft hydro breakline and contours in a dry drainage feature in order to “hydro-enforce” that feature by filling the depressions and falsely scalping off the higher undulations in order to make an idealized monotonic dry streambed out of the true undulating streambed. To “hydro-enforce” such a dry streambed would be to falsify the true topography of naturally undulating terrain. The soft hydro breaklines are part of the hydrographic feature class, but have a separate sub-class code, 3. This enables hydro-enforced hydrographic features, sub-class codes 1 and 2 for single and dual lines, to be distinguished from these non-hydro-enforced soft hydrographic features representing dry drainage features.

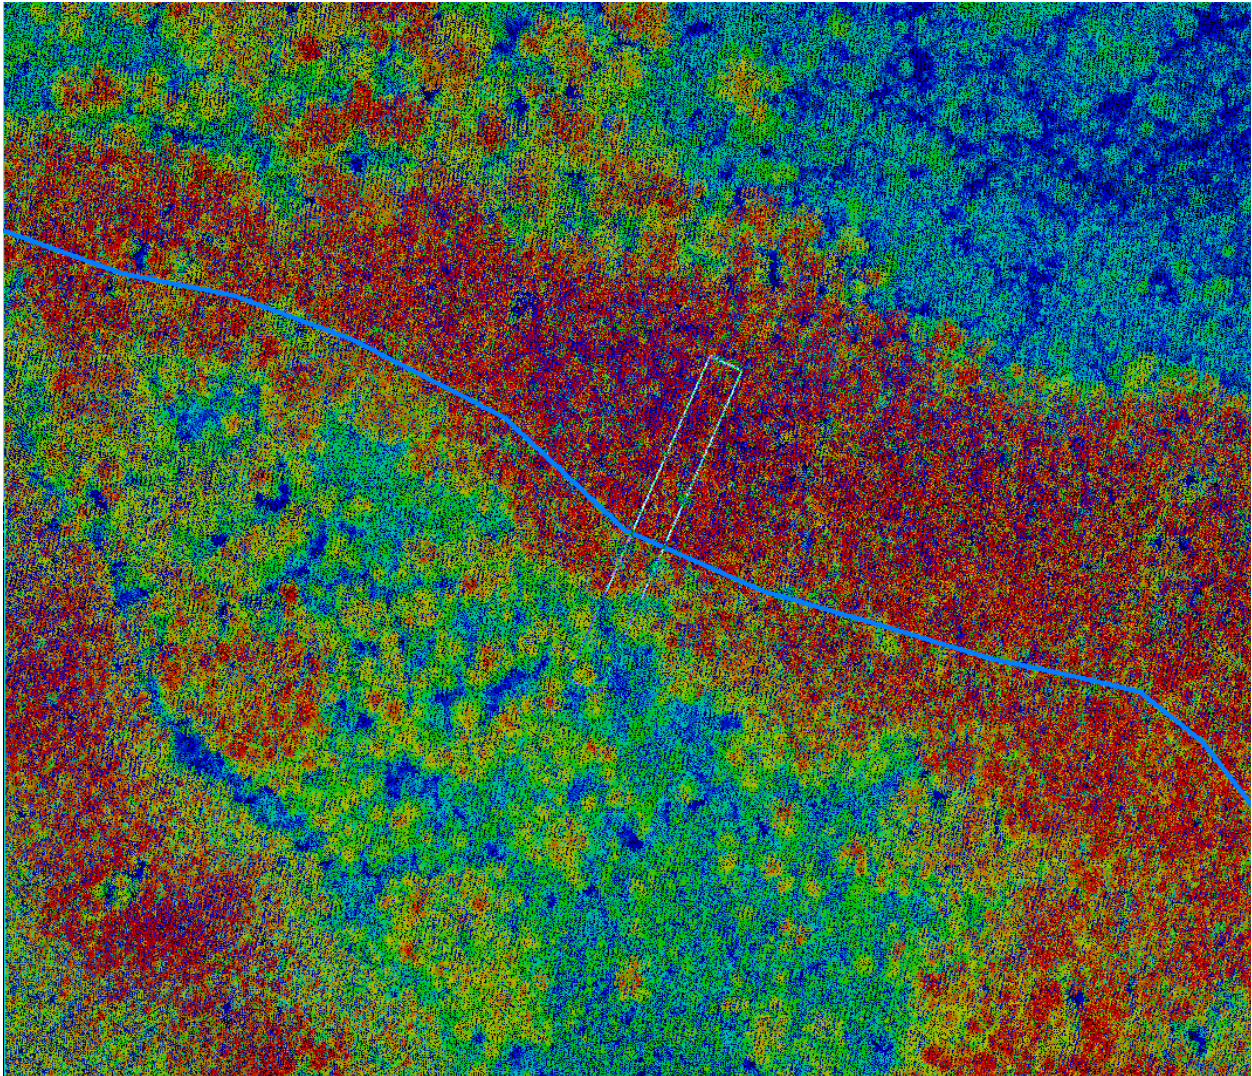
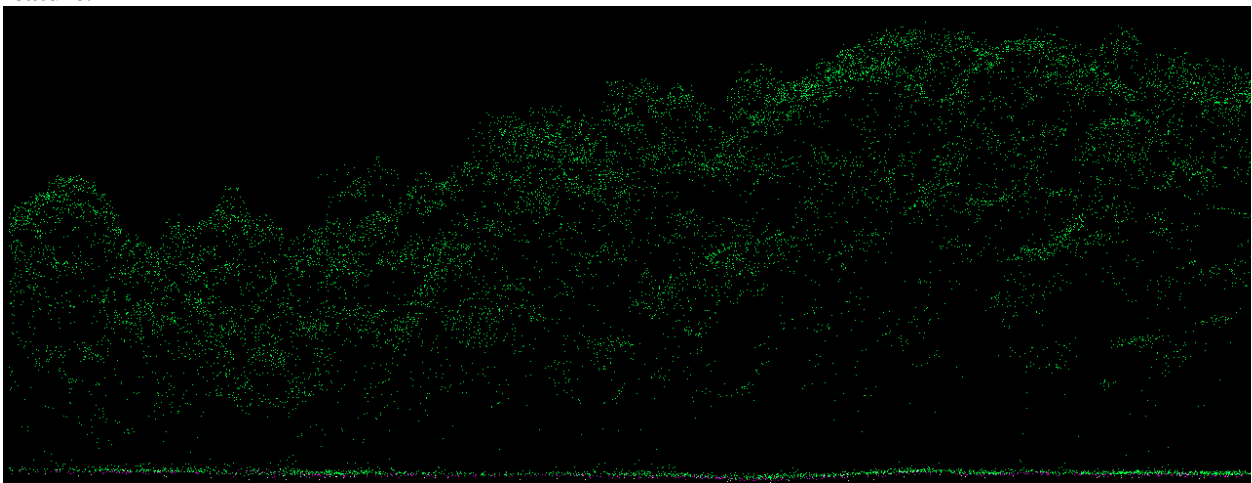
Figure 4. Full point cloud with profile (below) showing density of vegetation in the area of the dry drainage feature.

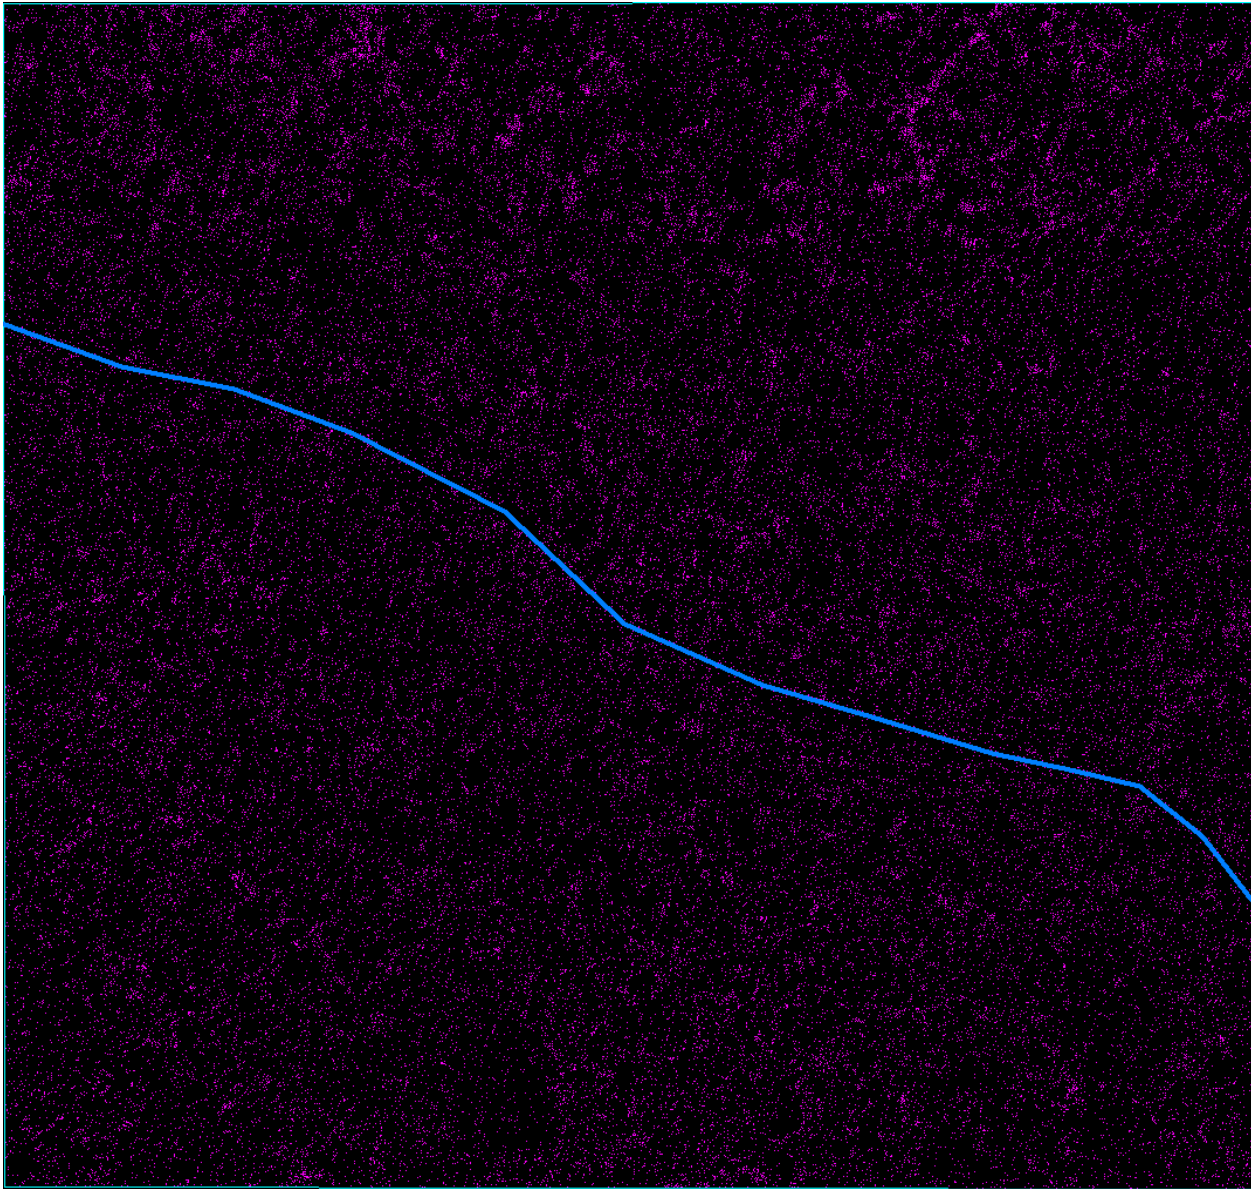
Figure 5. LAS Class 2 (ground) points showing the high density of points that penetrated the vegetation.

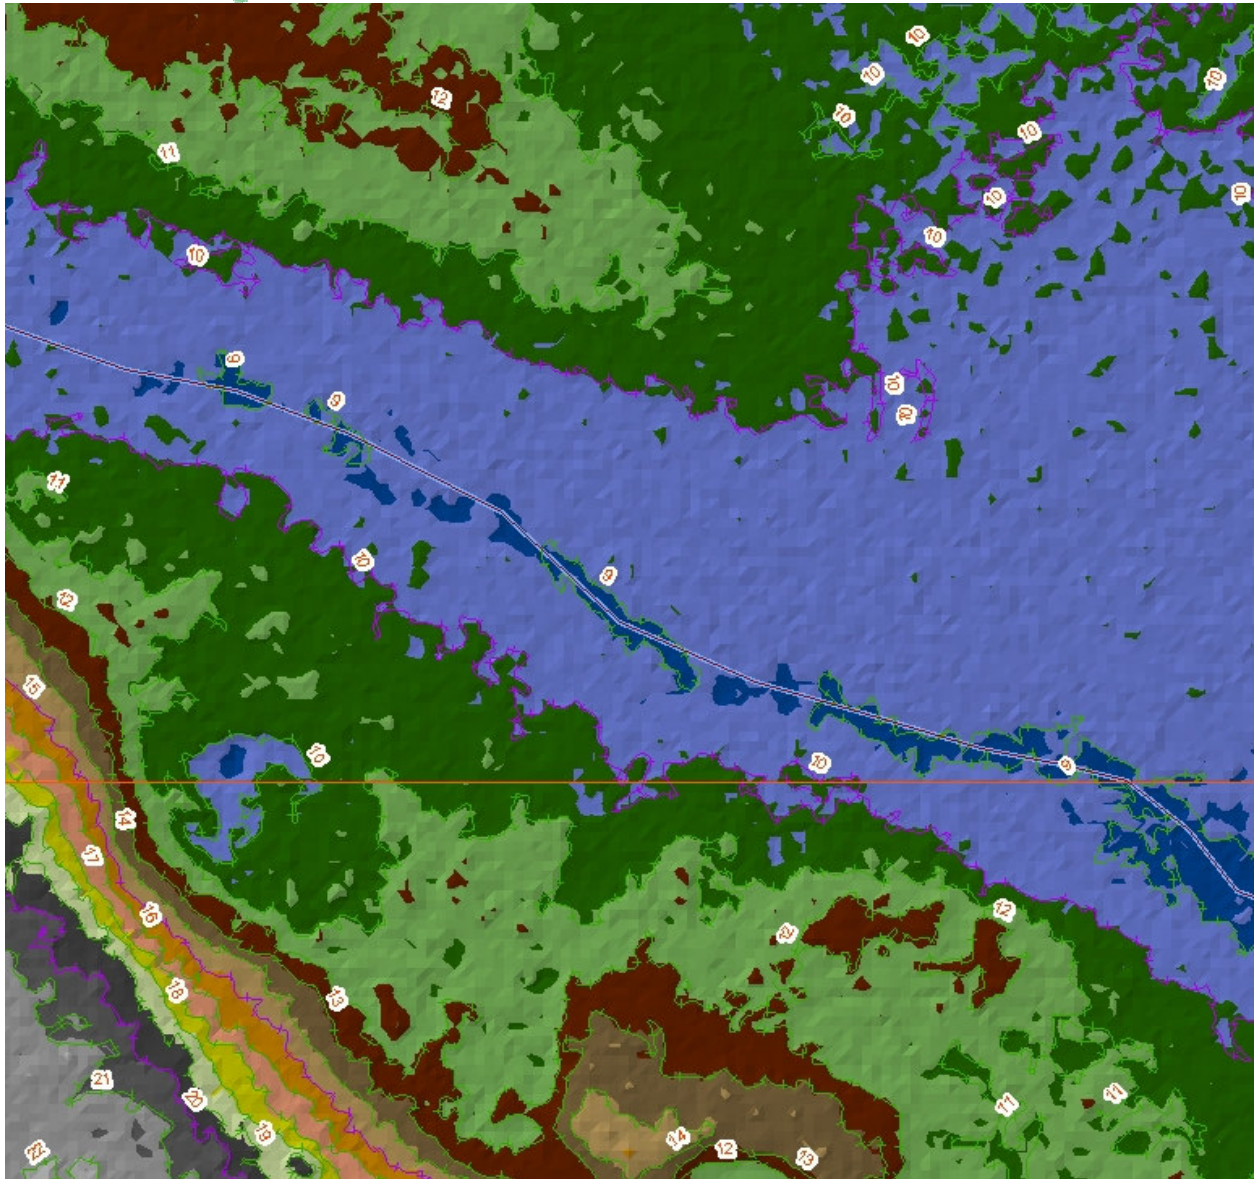
Figure 6. The ESRI Terrain is color-coded to depict the variable elevation bands. This clearly shows the lower, undulating elevations in the dry drainage feature.

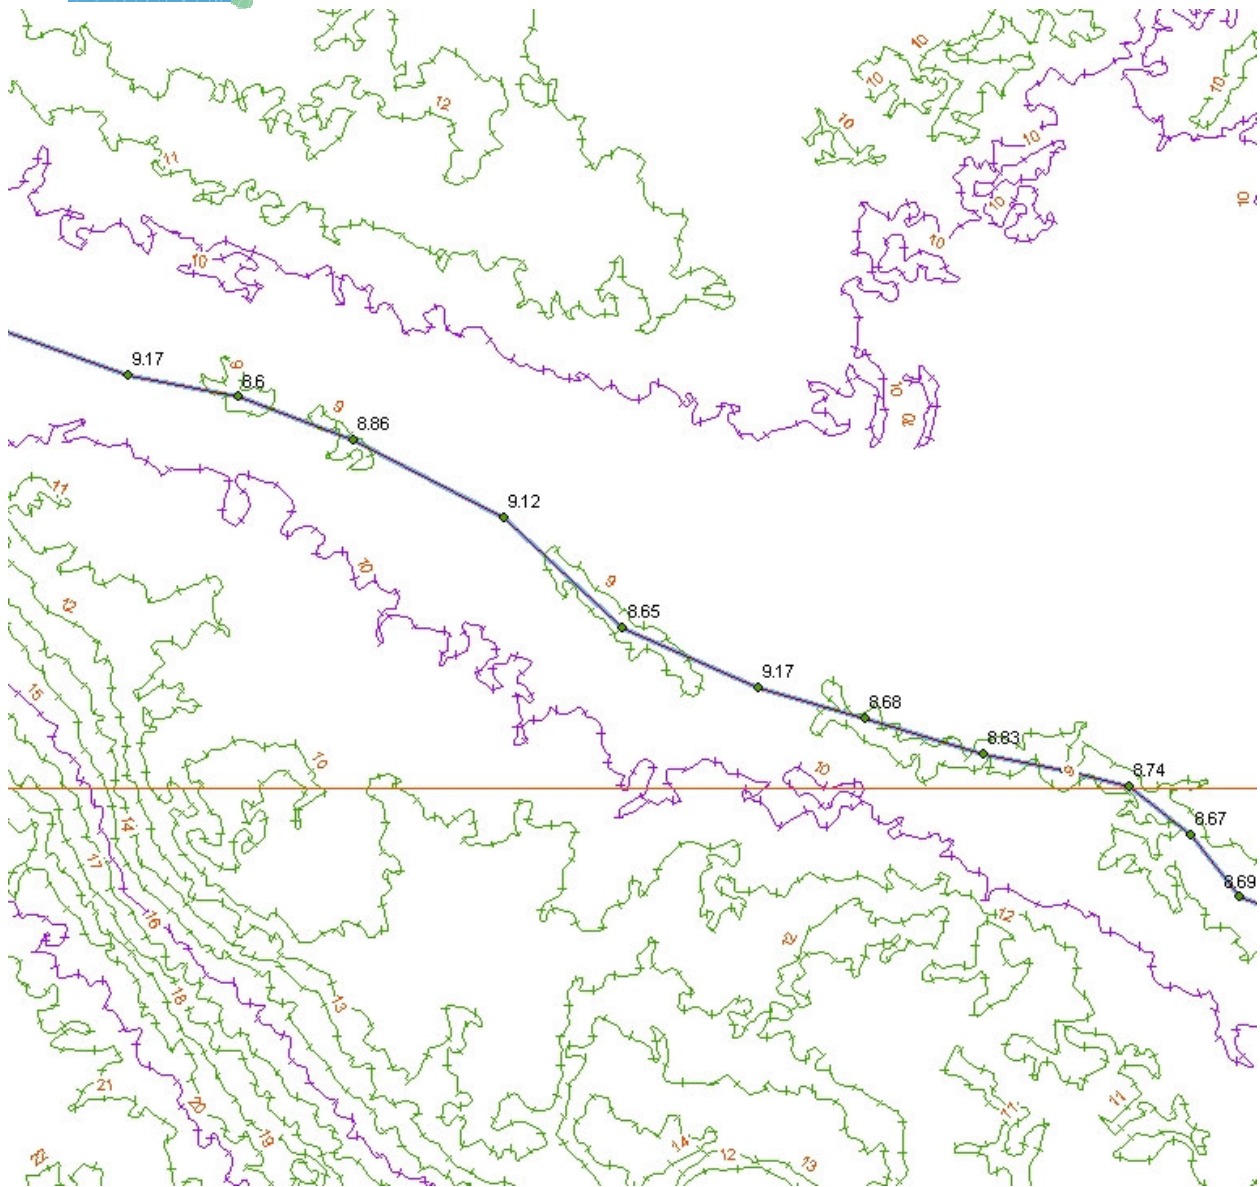
Figure 7. This figure shows variable “invert elevations” along the soft hydro breakline. It also shows “depression contours” where water would normally puddle if the drainage feature was only half dry. The soft hydro breakline passing through the “depression contours” clearly depict elevations lower than the 9-foot contour lines.

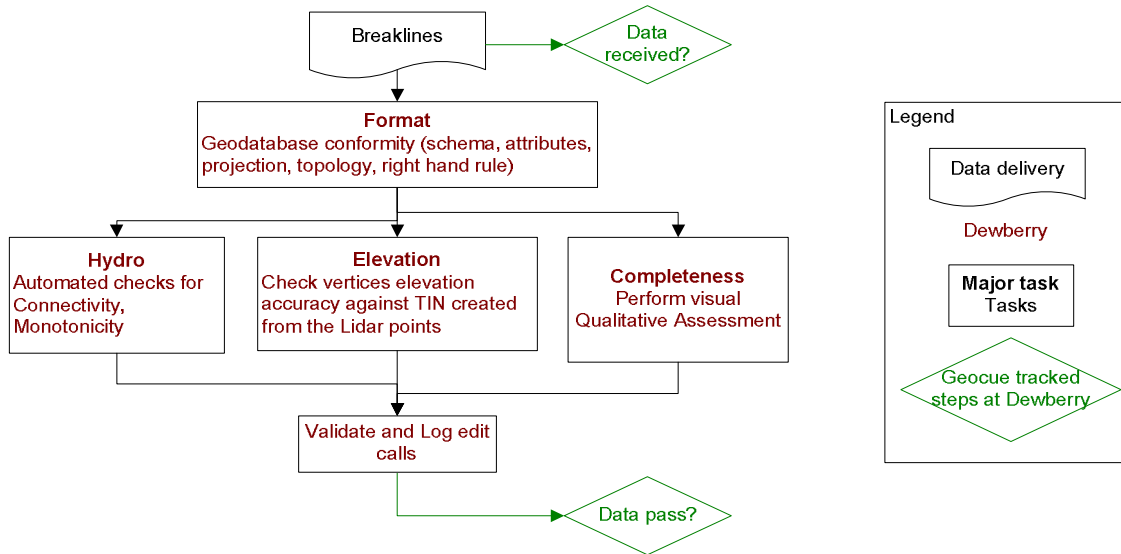
Dewberry performed the breakline qualitative assessments. The following workflow diagram represents the steps taken by Dewberry to provide a thorough qualitative assessment of the breakline data.

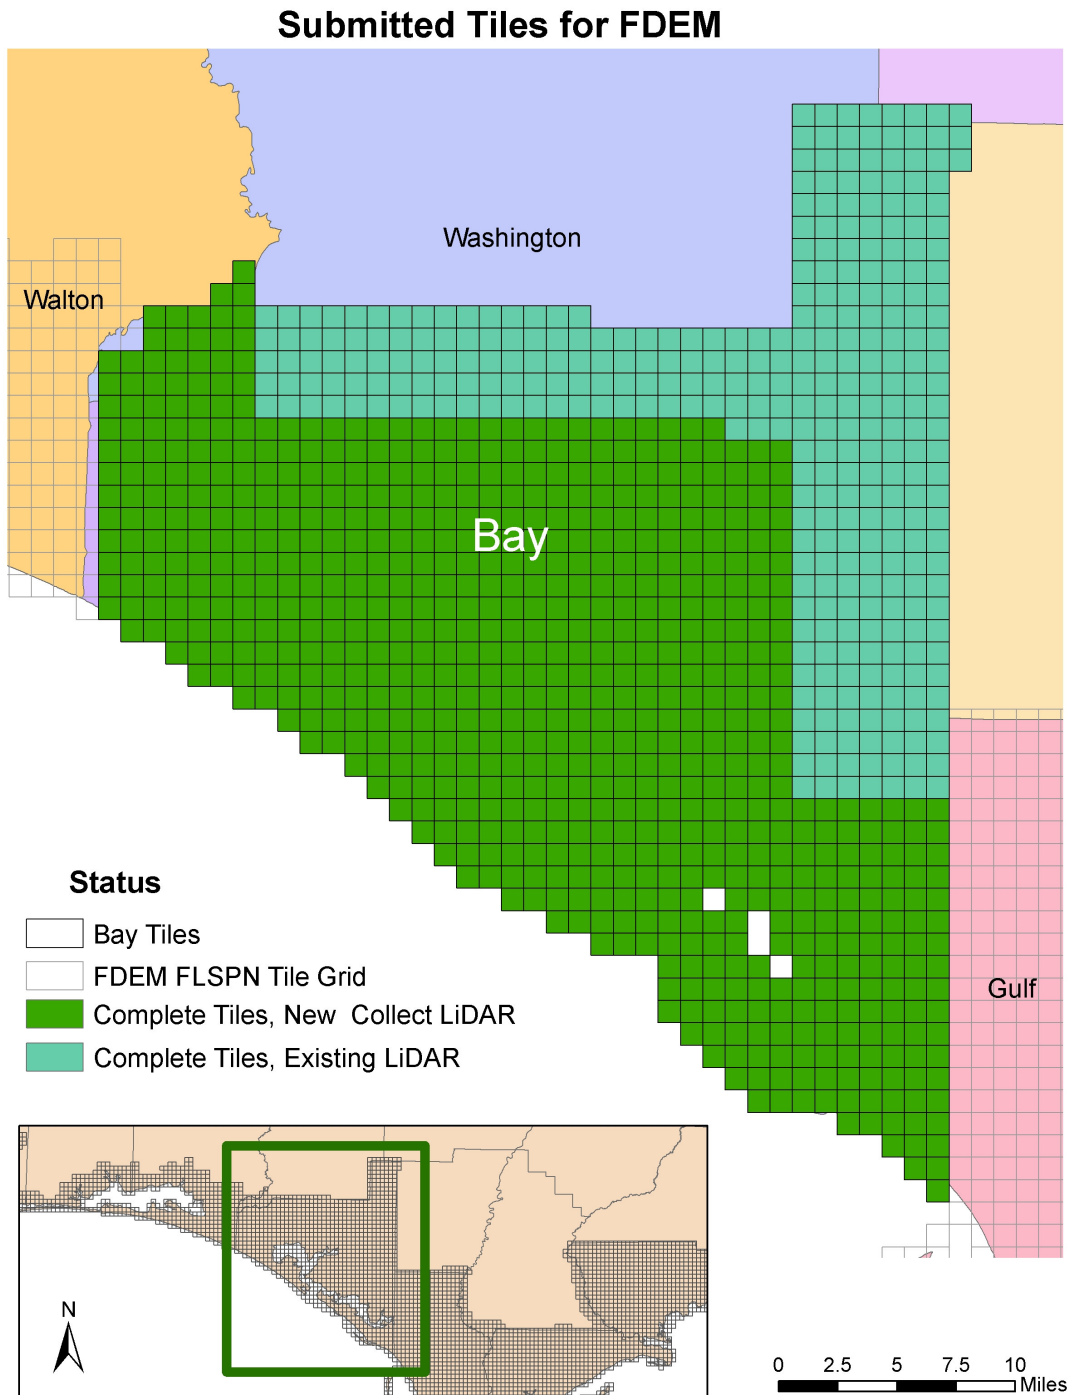
Appendix A: County Project Tiling Footprint

1074 Tiles Delivered

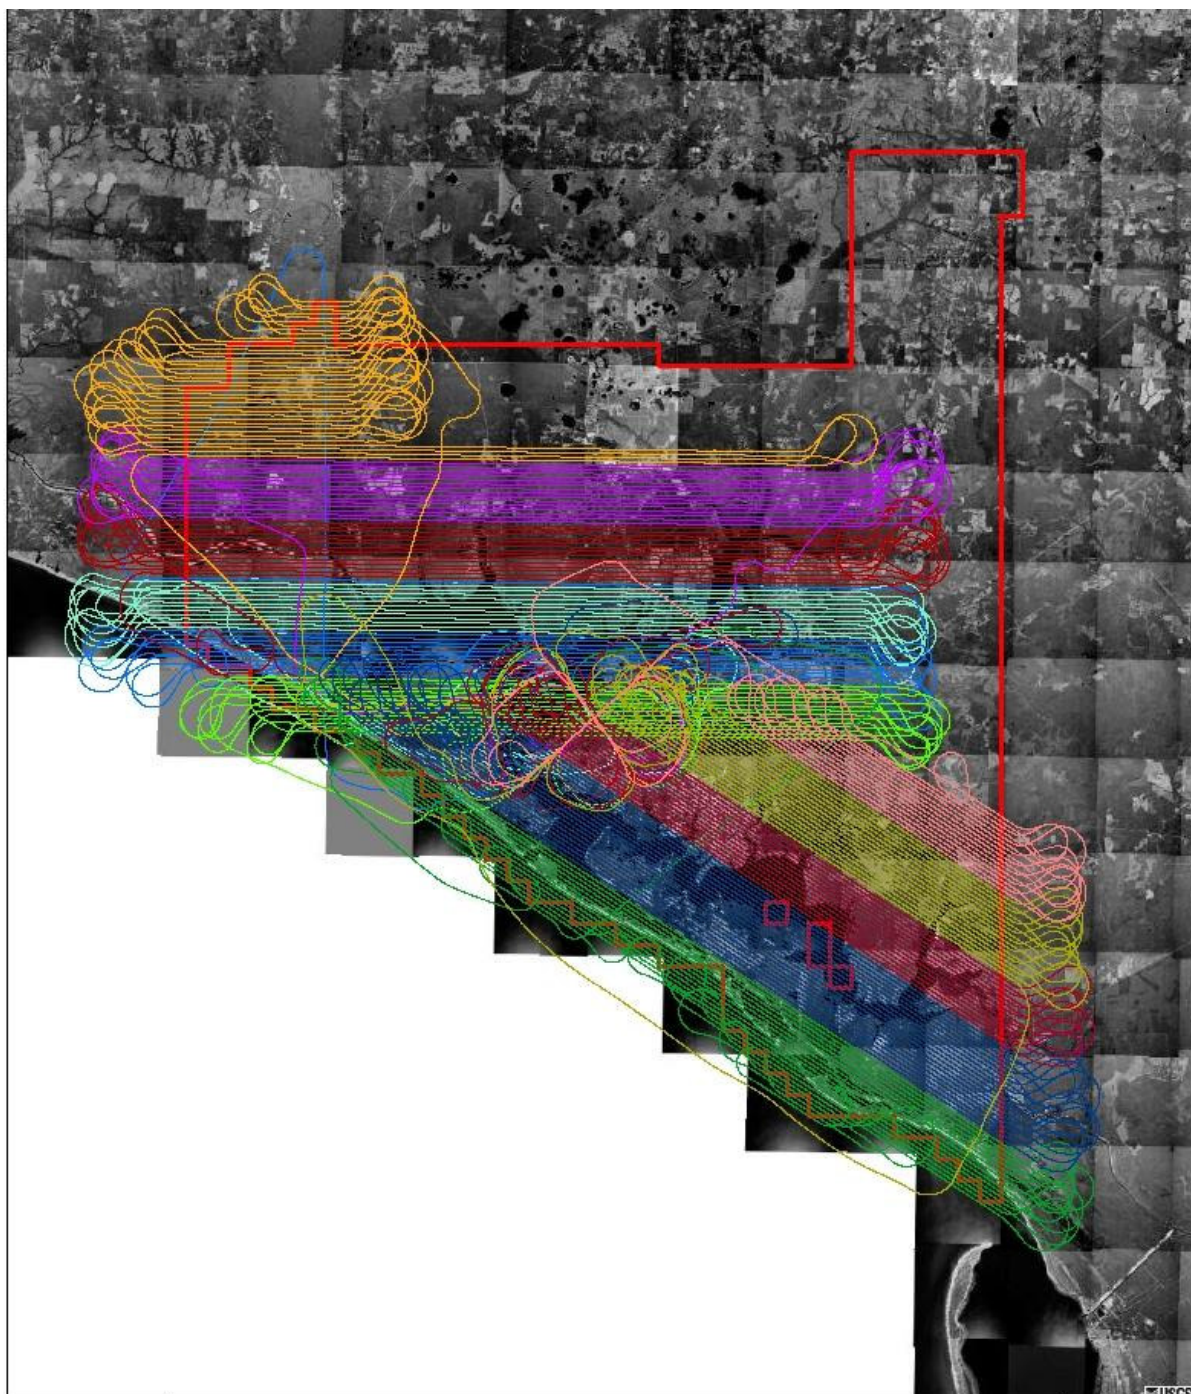
Figure 1: Area of Collection
(The area displayed in orange is Bay County)

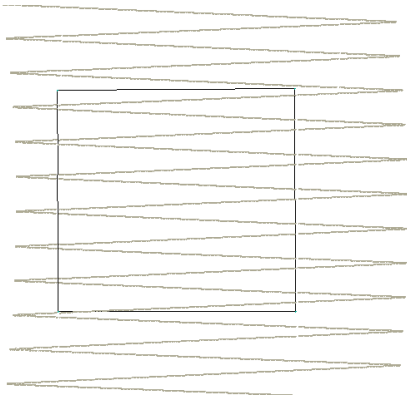
Figure 2: Calibration Pass 1

Additionally, a pass is made in profile mode across the middle of the building to compensate for any bias in pitch.

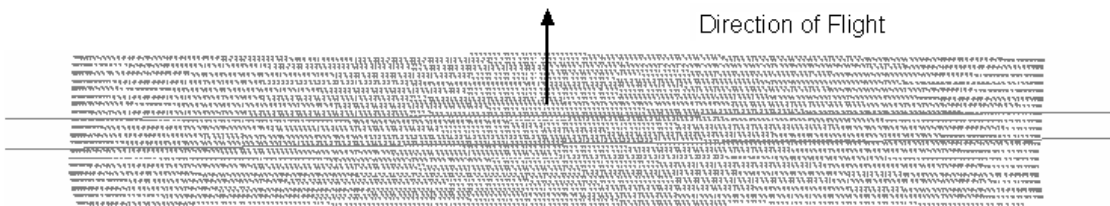
Figure 4: Runway Calibration

Approximately 25,000 LiDAR points are observed with each pass. A Triangulated Irregular Network (TIN) surface is created from these passes. The ground control x,y,z points are then compared with the z of the LiDAR surface to compute vertical residuals of the LiDAR data. After careful analysis of noise associated with non-runway returns, any system bias is documented and removed from the process.

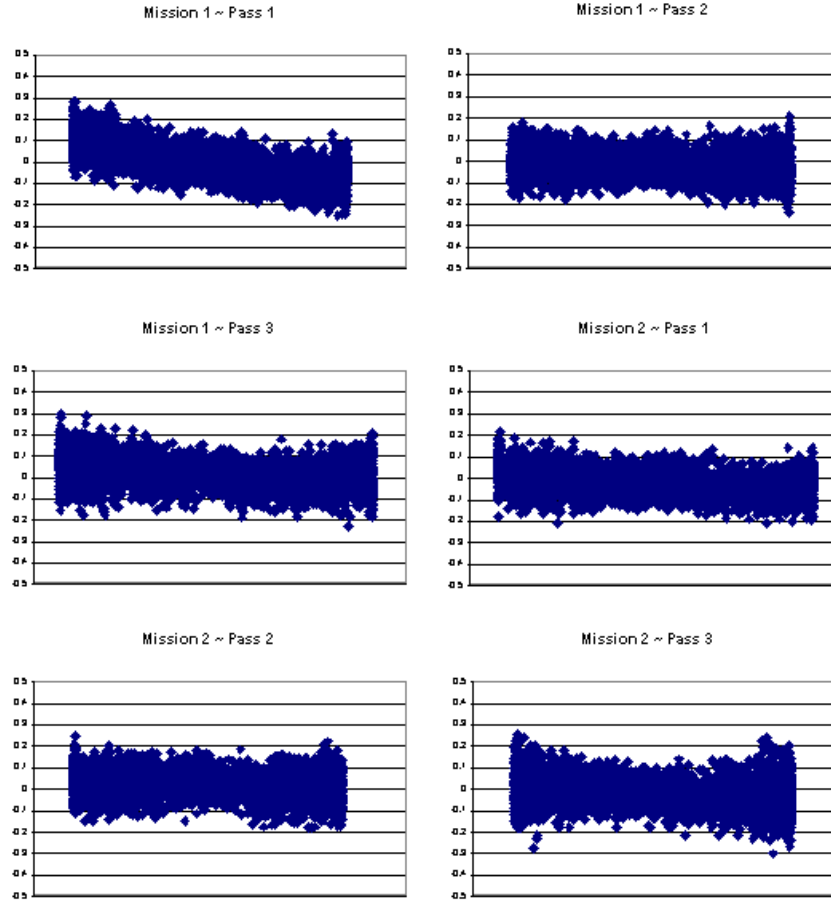
Figure 5: Runway Calibration Results

The calibration is done based on a kinematic survey on the runway. Given that the Kinematic survey RMSE is no better than 4 centimeters as a result of non- exact height of the antenna and weight of the aircraft. Sanborn was required to do additional check points in the project area to meet the 9.25 centimeter vertical accuracy requirement knowing that the calibration site is only good to 4 centimeters RMSE. A z bump adjustment was made to the entire data set based on the survey points in the project area and the relative accuracy of the data to itself and in all areas.

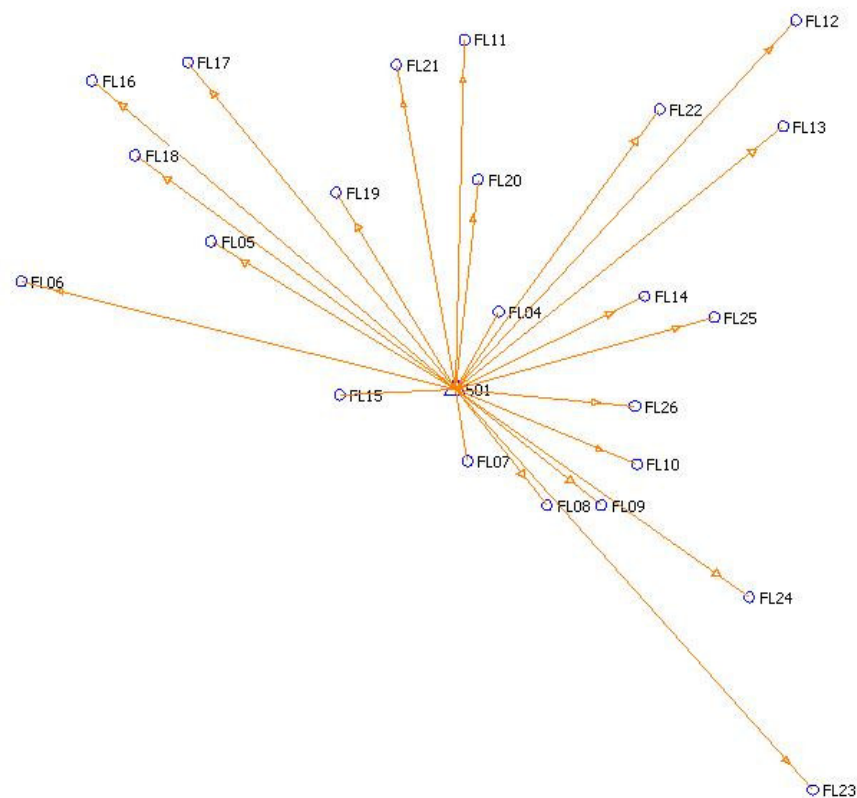
Figure 6: FDEM Survey Checkpoint Diagram

Figure 6 shows a diagram of the collected checkpoints for Bay County. For the Bay County checkpoint control report the standard deviation is 0.237 feet and the root mean squared is 0.296 feet. The LiDAR data was compared to each of these classes yielding better results than was required for the project. Points indicating removed are points outside the statistical variance in the data. Table 8 indicates the results for Bay County and each point including the overall results as it compares to the LiDAR data set.

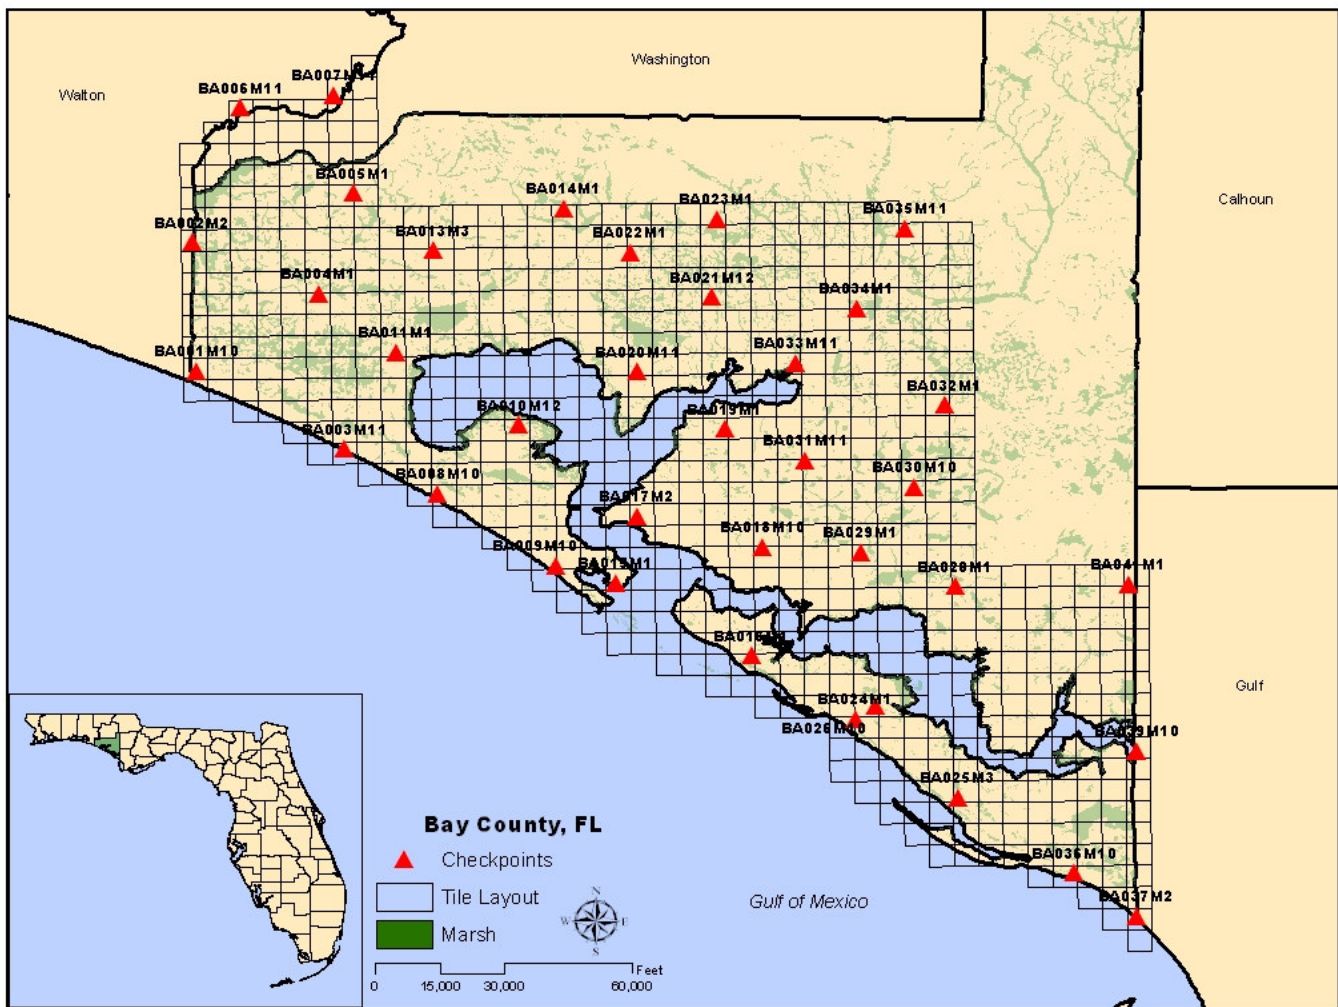
Figure 1 — Location of QA/QC Checkpoint Clusters for South Bay County

Figure 1 shows the location of the QA/QC checkpoint clusters within South Bay County. Each point represents a checkpoint cluster and each cluster includes checkpoints in different land cover categories. There are nominally four checkpoints in each cluster, one per land cover category.

1. PDS surveyed "ground truth" QA/QC vertical checkpoints in accordance with guidance in references B, C, D and E. Figure 1 shows the location of "cluster areas" where PDS attempted to survey a minimum of 30 QA/QC checkpoints in each of the four land cover categories. Some cluster areas did not include all land cover categories. The final totals were 36 checkpoints in bare-earth and low grass; 36 checkpoints in brush and low trees; 37 checkpoints in forested areas; and 31 checkpoints in urban areas, for a total of 140 checkpoints.
2. Next, PDS interpolated the bare-earth LiDAR DTM to provide the z-value for each of the 144 checkpoints.
3. PDS then computed the associated z-value differences between the interpolated z-value from the LiDAR data and the ground truth survey checkpoints and computed the FVA, CVA and SVA values using procedures in References D and E.

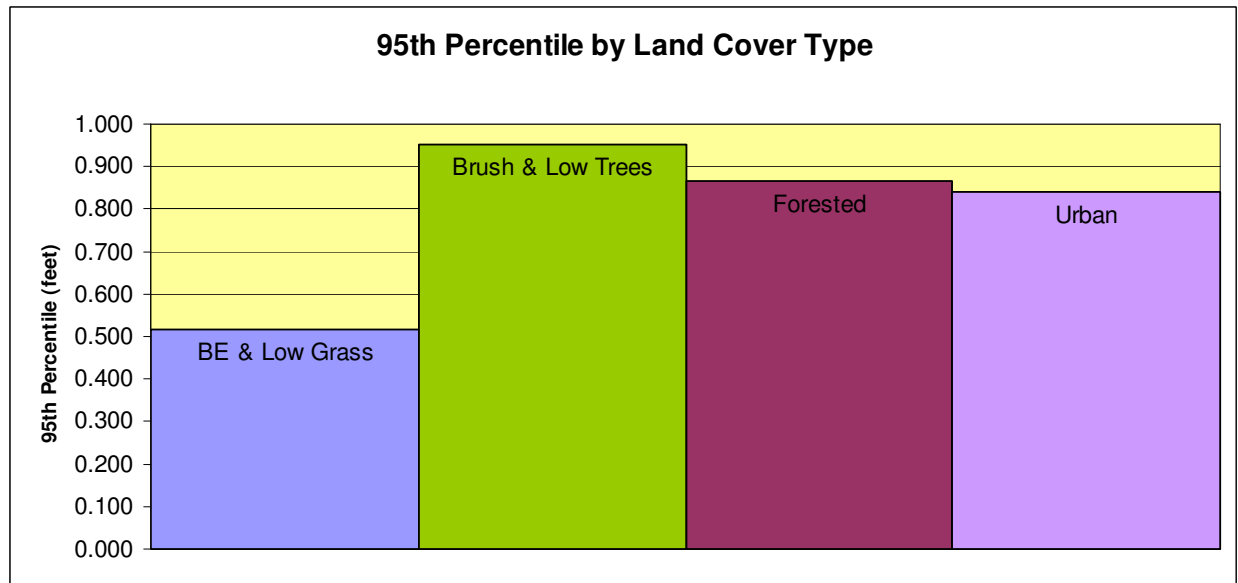
Figure 2 — Graph of SVA Values by Land Cover

Figure 2 illustrates the SVA by specific land cover category.

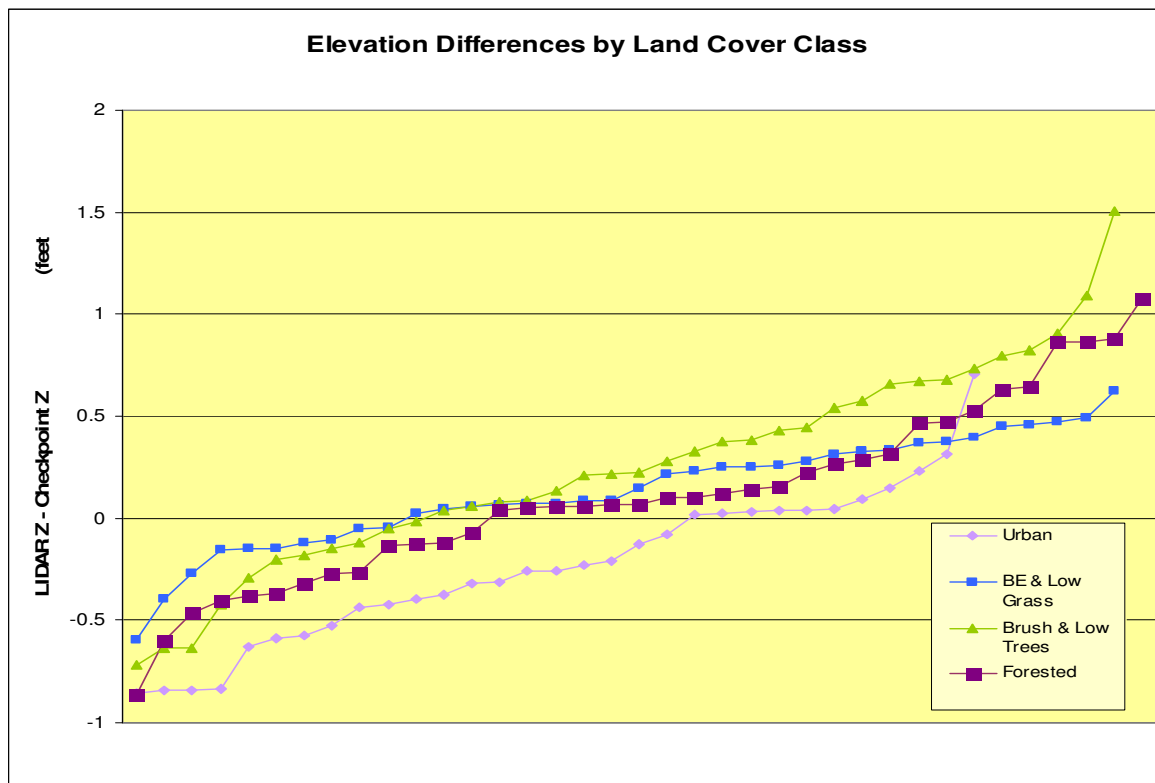
Figure 3 – Magnitude of Elevation Discrepancies, Sorted from Largest Negative to Largest Positive

Figure 3 illustrates the magnitude of the differences between the QA/QC checkpoints and LiDAR data by specific land cover category and sorted from lowest to highest. This shows a normal distribution of points in all categories. One category 2 checkpoint in the brush and low grass exceed the 1.19 ft SVA accuracy criteria by 0.31 ft.

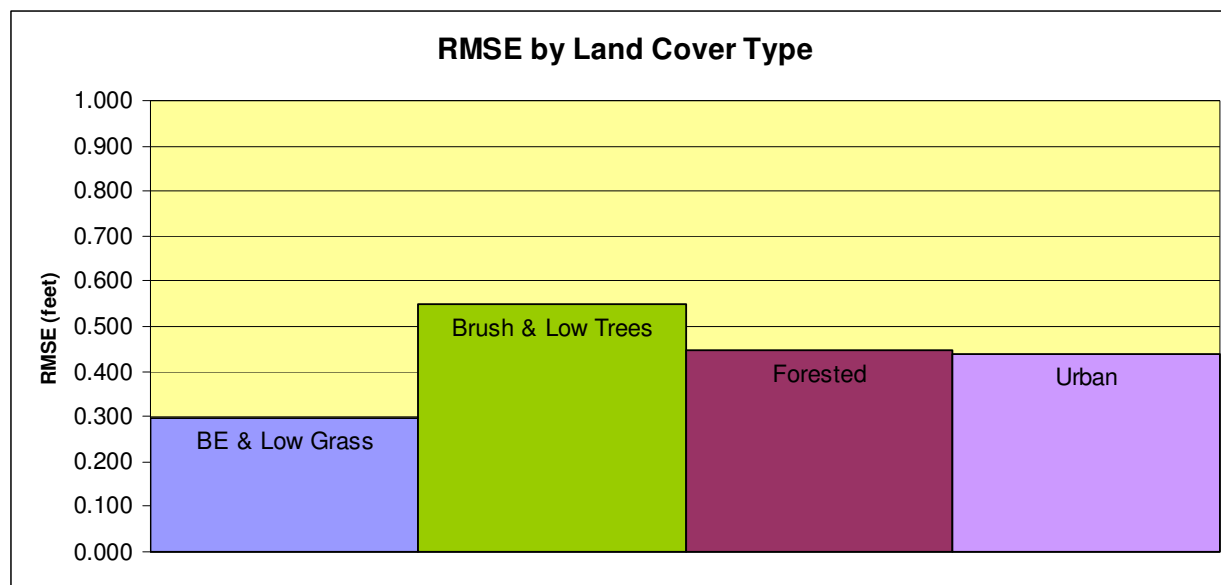
Figure 4 — RMSE_z statistics by Land Cover Category

The NSSDA and FEMA guidelines were both published before it was recognized that LiDAR errors do not always follow a normal error distribution. Future changes to these FGDC and FEMA documents are expected to follow the lead of the NDEP and ASPRS. Nevertheless, to comply with FEMA's current guidelines in Reference C, RMSE_z statistics were computed in all four land cover categories, individually and combined, as well as other statistics that FEMA recommends to help identify any unusual characteristics in the LiDAR data. These statistics are summarized in Figures 4 and 5 and Table 4 below, consistent with Section A.8.6.3 of Reference C.
